# In-situ Damage Assessment on Supporting Structure of Coal Conveyor

Meilinda Nurbanasari\*

**Abstract.** The supporting structure of conveyor in a coal power generation plant located in marine environment, was experiencing severe filiform corrosion. The structure has been used since 2009. This supporting structure holds the conveyor for coal transportation from the ship to the turbine. From visual inspection, it was clearly seen that around 80 % of total area of the structure has been corroded, which influenced the strength of the structure. Hence damage evaluation of supporting structure was important to be carried out to determine the level of damage and to give the recommendation for repairment strategies. The damage evaluation method consisted of thickness measuring, chemical composition test, hardness test, microstructure analysis using replica technique and deposit analysis using SEM-EDS. The result showed that the type of material structure was AISI 1020. The highest reduction in measured thickness was 44 %, which occurred dominantly on bottom and top flange of the structure. It was also found that in some joint areas, the material was perforated. The deposit analysis usi

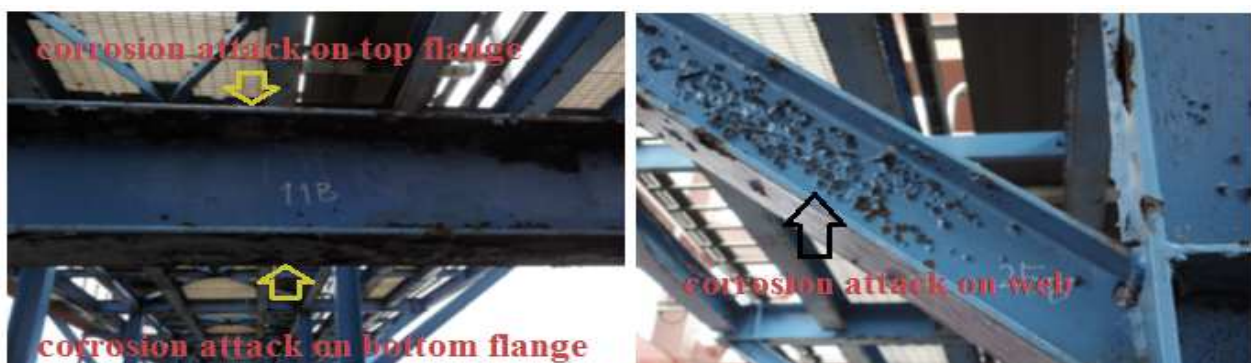
Fig.1 Corrosion attacks on top and bottom flange (left) and on web (right).

Figures 1 and 2 show that steel beam structures have been attacked by filiform corrosion in which the corrosion products of a filamentous appearance under coating / paint layer. The corrosion had occurred uniformly on top and bottom flanges and took place around 80 % of total area the flange (see Fig. 1), whereas in other areas (see Fig. 2) the corrosion attacks on joint caused the material was perforated. By considering the function of the structure, it is very important to do the evaluation how severe the damage that had occurred due to corrosion attack. The results of the evaluation will determine the action to be taken for repairment strategies.

- a) When corrosion attacks is more than 30 % area either on top or bottom flange and the reduction thickness is more than  $> 30\%$  hence the top or the bottom flange must be replaced by a new one with the same steel. However, if severe corrosion occurs on the web then replacement should be done by replacing the new whole beam of steel.

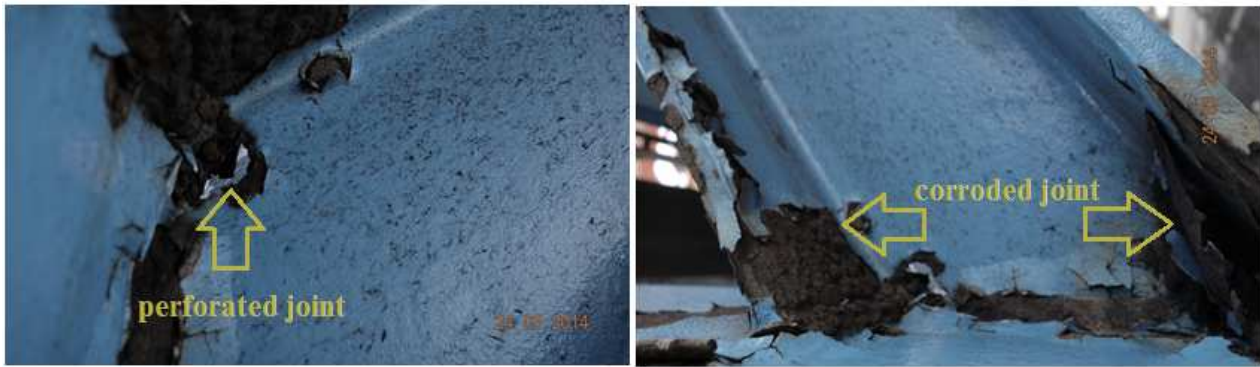
Fig.2 Corrosion attacks on joint areas.

- b) The material joint that has been perforated must be replaced with a new one with the same type of steel
  - c) The paint system must follow the standard of BS/EN ISO 12944-5 in accordance with the environmental category of C5I.

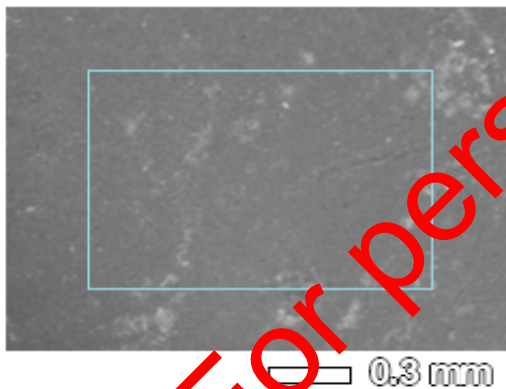
Fig.3 SEM-EDS result of coating protective layer.

The SEM-EDS results of coating layer (Fig. 3) shows that the elements detected by SEM-EDS were C, O, Mg, Al, Si, Cl, Ca, Ti and Cu. The presence of Cl was not surprising as the steel structure located in the marine (seaside) environment. Figure 4 shows the XRD results. The peaks were in good agreement with  $\text{TiO}_2$  (powder diffraction file: 21-1276),  $\text{CaCO}_3$  (powder diffraction file: 005-0586), and  $\text{CaMg}(\text{CO}_3)_2$  (powder diffraction file: 036-0426). No indication the presence of Zn either from SEM-EDS or XRD results in which the zinc element or compound should exist as a protective coating layer.

Based on ISO 9223:1992 [4], the environment of the supporting structure was categorized in C5I, e.g.; industrial areas with high humidity and aggressive atmospheres. The corrosion risk of that environment is very high. By considering the steel structure environments was very high corrosion risk, the choice of type of coating became very important. Previous studies [5,6] reported that the application of zinc rich coating metal substrates is a very efficient approach of corrosion resistance protection and has been widely used in many aggressive media such as sea water, marine and industrial environment. According to BS EN ISO 12944: 1998 [7], the coating system for low-alloy carbon steel with environment categories C5-1 must use zinc rich epoxy primer as a primary coat, high build epoxy MIO (micaceous iron oxide) as an intermediate coat and high solid aliphatic polyurethane finish as a top coat. From this point of view, it can be concluded that the paint system used on the steel structure did not meet the coating standard requirement for the category of C5I environment.

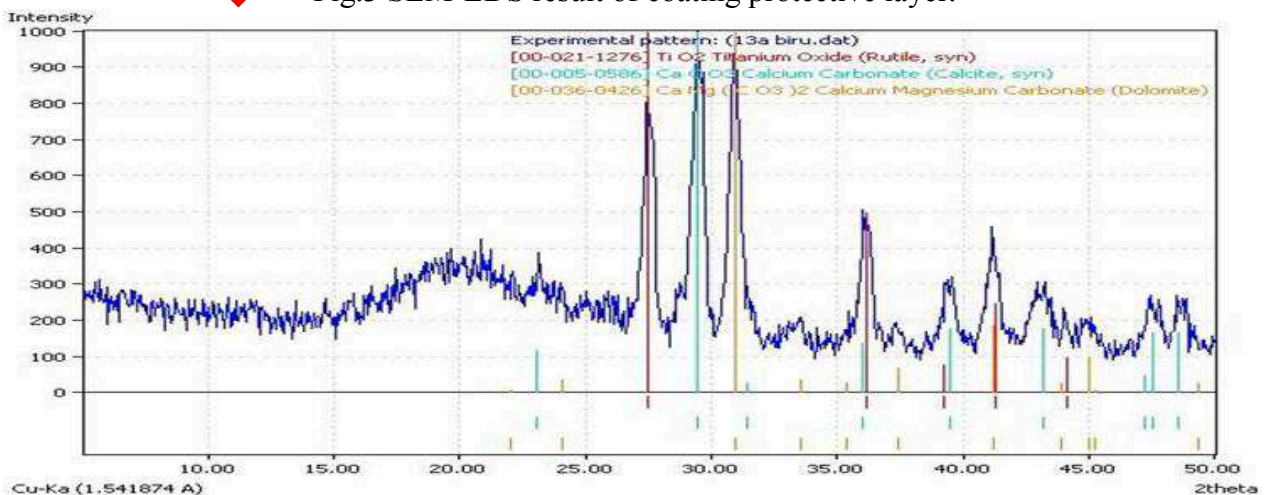
Fig.4 X-ray diffractograms of coating layer.
