Investigation of Leakage on Water Wall Tube in a 660 MW Supercritical Boiler

Journal of Failure Analysis and Prevention

J Fail. Anal. and Preven. (2014)
14:657-661
DOI 10.1007/s11668-014-9861-z

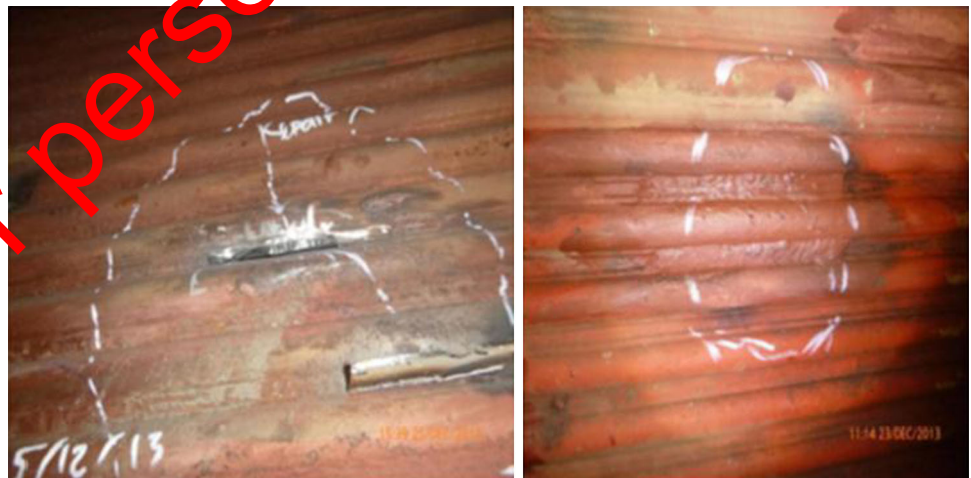
From the on-site investigation, five leaks were found at different locations on the water wall, and some of them are

Fig. 1 The leaking water wall tubes in a 660 MW supercritical boiler

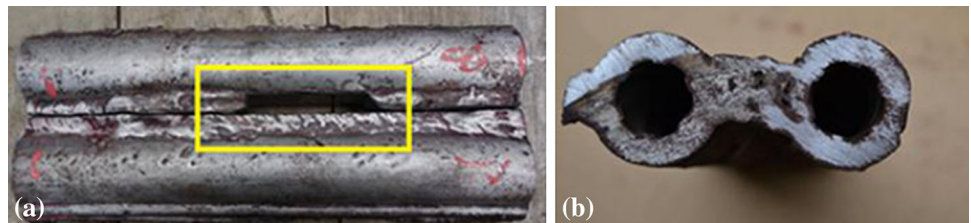
Fig. 2 Leaking tubes with a yellow rectangle indicating the leak location (a) and cross section of leaking tube (b)

Figure 2 presents the investigated tubes in which leakage was observed in between tube parenting material and the weld metal (indicated by a yellow rectangle). The cross section of the leaking tubes (Fig. 2b) shows the inner surface geometry of the tube is ribbed.

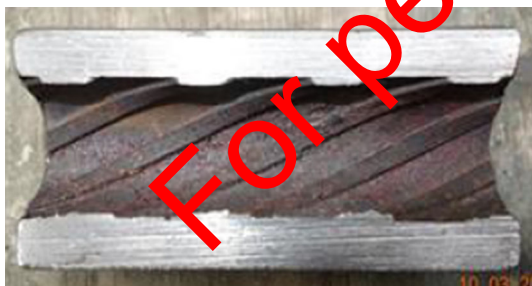
The type of tubes was seamless, and from the longitudinal section, the inner surface geometry was spiral or multi-lead ribbed (see Fig. 3).

Fig. 3 Inner surface geometry of a leaking tube showing typical multi-lead ribbed geometry

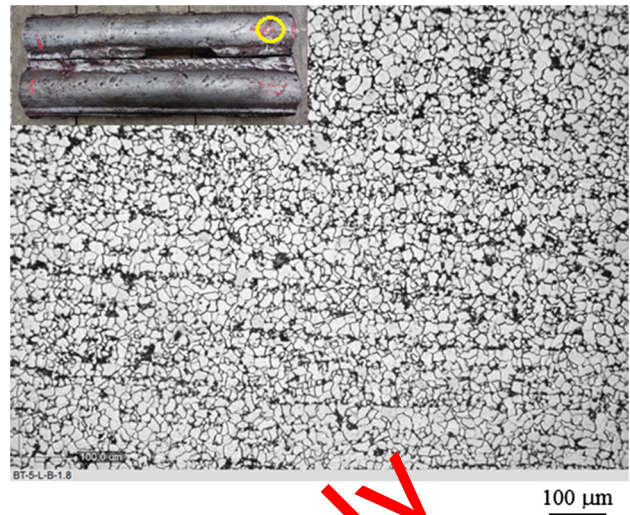
Figure 4 shows the parent material microstructure of a leaking tube taken near the external surface. The microstructure consisted of equiaxed ferrite and banded pearlite. The banding was a consequence of hot deformation, and it suggests that the tubes had experienced a hot extrusion during the manufacturing process. From chemical composition, hardness data, and microstructure of the tube, the

Fig. 4 An optical image of leaking tube microstructure (inserted figure shows a sample taken for microstructure analysis)

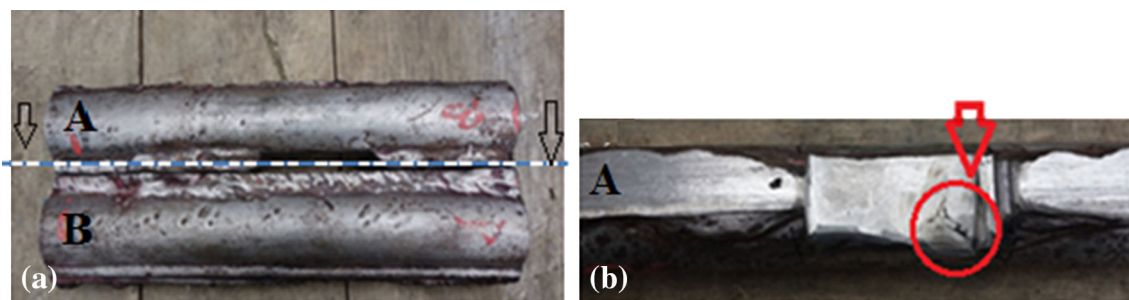
Figure 5a shows the welded tubes that were cut in longitudinal section. After grinding on the surface of the leaked tube-A, it was clearly seen that there was a crack that might be a leak path (indicated by red circle in Fig. 5b). Tube-A was chosen for deeper investigation. To get more detail of the crack path, the tube was cut gradually as presented in Fig. 6.

Fig. 5 The leaking tubes were separated in the longitudinal direction as indicated by the dashed line (A and B) (a) and cracks appeared after grinding on one of the separated tubes (b)

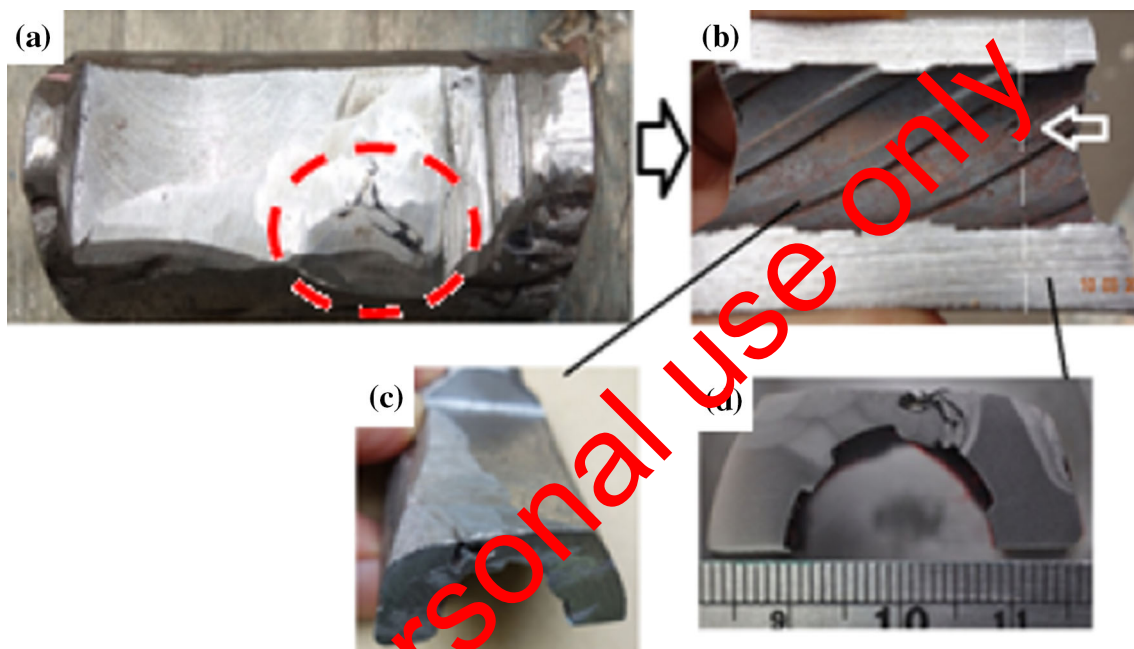
Figure 6a shows the cracks on the tube-A, and the longitudinal section of the tube revealed that there was a defect on the inner surface of the tube (Fig. 6b) as shown by an arrow. It is believed that the crack seen in Fig 6a was initiated from the external surface in welded zone and propagated to the inner surface of the tube, causing a gap inside the tube material as a source of leakage. For confirmation, the sample was divided into two sections in the cracked zone in the transverse direction, as indicated by the dashed line in Fig. 6b.

Both Fig. 6c, d give strong evidence that the cracks occurred from the external surface on the side of the welded tube and propagated to the inner surface. Microstructural analysis with a scanning electron microscope on the sample in Fig. 6d was carried out to supplement these observations (Fig. 7).

Fig. 6 Section of tube in the longitudinal direction (a, b, c) and section of tube in the transverse direction after polishing (d)

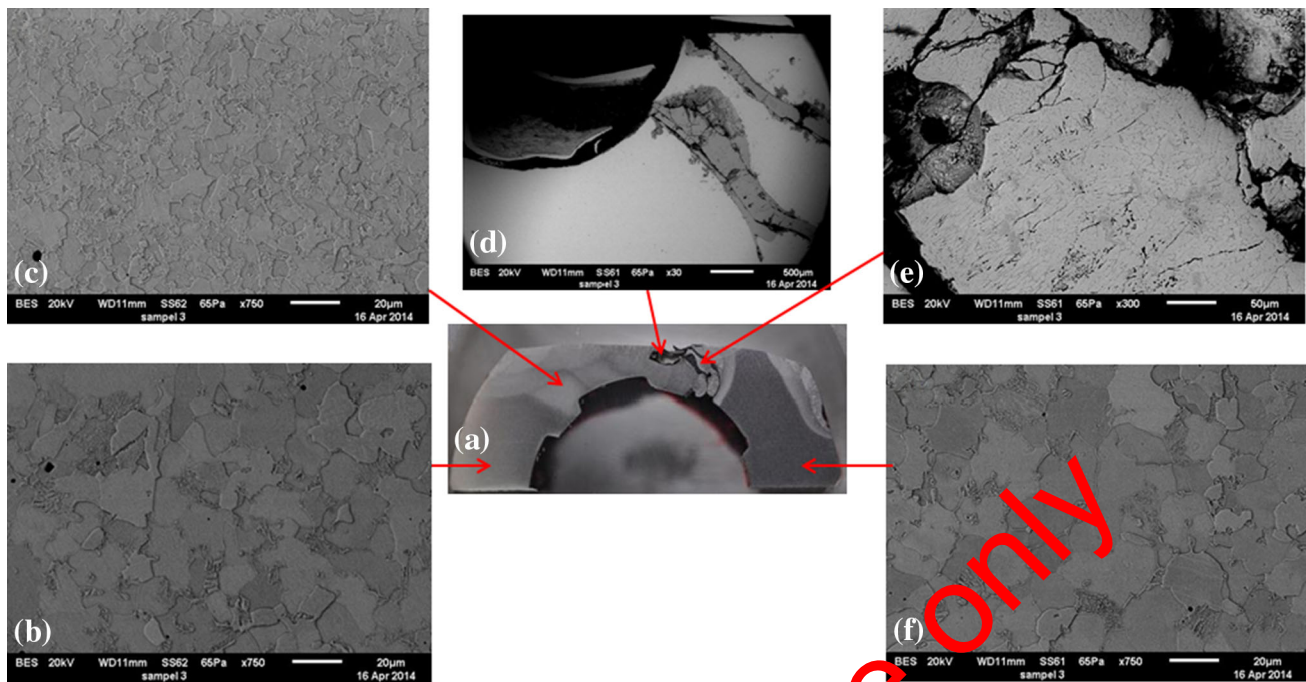
Figure 7 shows various microstructures taken from different areas around the leak. The overall section is shown in Fig. 7a. The microstructures of the parent material tube, which can be seen in Fig. 7b, f show that the grain structures are homogeneous equiaxed ferrite and pearlite. As this sample was taken from the transverse plane, the equiaxed ferrite and no seam on the tube indicate that this tube was a hot extruded product. Figure 7 also shows that the welding process was carried using multipass method, which is indicated by multiple heat-affected zones (HAZ). The Fig. 7c reveals that the grain structures in the HAZ were finer than those of the parent material (Fig. 7b, f) due to repeated heating [7]. Note that in multipass welding, a weld zone is replaced by a HAZ of subsequence passes. Figure 7d shows a cavity observed in the section. This cavity seems to have formed during the welding process. There was improper welding parameter or procedure control causing overheat in a local area. As a result, excessive penetration occurred and the tube material melted going

through the inner surface of the tube. Overheating during welding also caused gas easily to be trapped in the melted material producing a cavity. At the same time, the flux of the electrode was also trapped in that area (Fig. 7e). Figure 7e shows a completely different microstructure than the others (Fig. 7c, b, f). These features are typical of a weld defect known as *excessive melt through* or *burn through* [8]. This weld defect is caused by incorrect parameter welding, resulting in overheating, or the fit-up gap between the tubes to be joined is too large [8].

The findings of the investigation verified that the tube material met the standard. The main cause of leakage on the water wall tube was the formation of a weld defect known as *excessive melt through* or *burn through*, which was attributed to improper welding parameters or process variable control during fabrication.

Fig. 7 Back scatter electron images showing microstructures in various areas (for letters, see the text)

It is suggested that leakage could be avoided by controlling the heat input through the welding parameters during fabrication of the furnace walls. The distance between the tubes to be joined must be also considered. The weld joint design was butt and the gap between the external surface of the tube has the range of 5–10 mm. It seems that using a

steel plate between the two tubes to provide a smaller fit-up gap could be implemented.
